MACS Service Reports

By Paul Weissler – MACS Technical Correspondent

April 2004

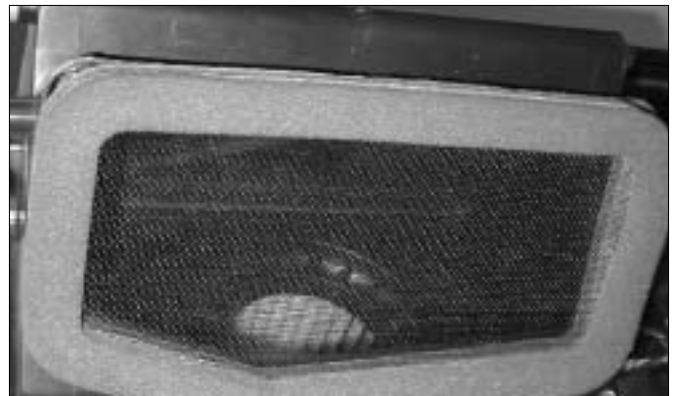
Figure 3. This air intake screen on a Saturn VUE gives you an idea of what GM is planning to release as a service part, and possibly as original equipment on vehicles without an air intake filter.

The screens reportedly will be similar to the type that Visteon supplies for the Saturn VUE (Figure 3).

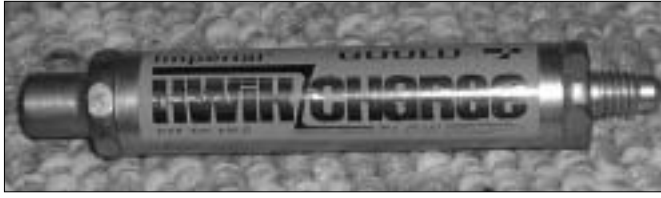
Figure 4. This is the old “Kwik-Charge,” which was sold to prevent compressor slugging from liquid charging into the suction side. We bought it in the days of CFC-12. It apparently has some sort of restriction to meter droplets of liquid refrigerant, and (what sounds like when we shake it) an anti-blowback valve in case it was connected to the high side.

Most systems have anti-slugging protection for the compressor, such as valves and accumulators, but “an attitude’s an attitude” and manufacturing engineers often get the final call — even if briefly. Old-timers may remember our fears about liquid slugging and our impatience with vapor charging way back in the CFC-12 days. If you’re in that class, you may remember the Imperial Kwik-Charge, a gadget that was supposed to allow liquid charging safely, by metering droplets into the low side. Did it really work? Don’t know, only that we used it and never seemed to slug a compressor (Figures 4 and 5).

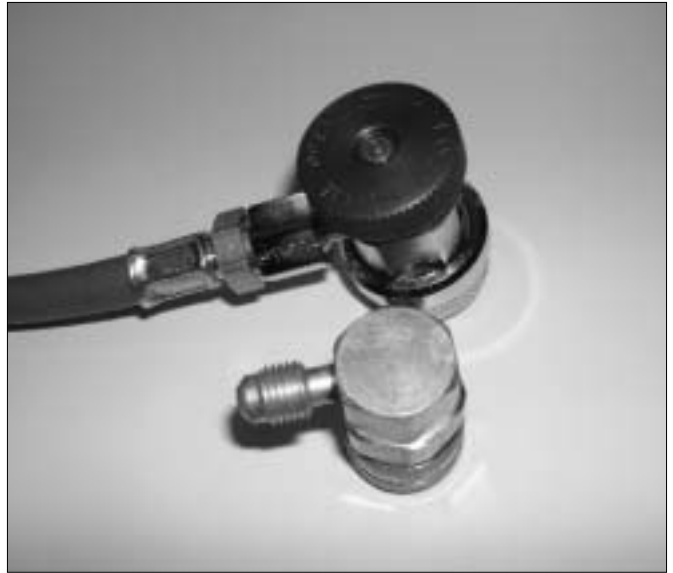
Figure 6. Two service hose couplings. The knurled knob on the larger one permits you to first install the coupling on the service valve, then turn the knob to push open the valve. The smaller one, although it goes into tighter quarters, may be more difficult to install because it requires a single push-on operation.

We noted the existence of ultra-compact service couplings (Figure 6) in the March, 2004 issue. These may fit in, but you have to push them on so they also depress the pin. They don’t have the knurled knob, which allows you to simply install the quick-connect and then manually turn the knob to depress the service valve pin. So unfortunately, they usually aren’t as easy to use in the tight quarters in which only they fit. An ultra-compact service coupling with a turn-down depressor would be a nice development. Of course, there are cases where you have to remove a pressure switch that’s on a Schrader-type service valve, then install an HFC-134a adapter. There you might be able to install the service coupling on the adapter first, and thread the assembly onto the “Schrader.”

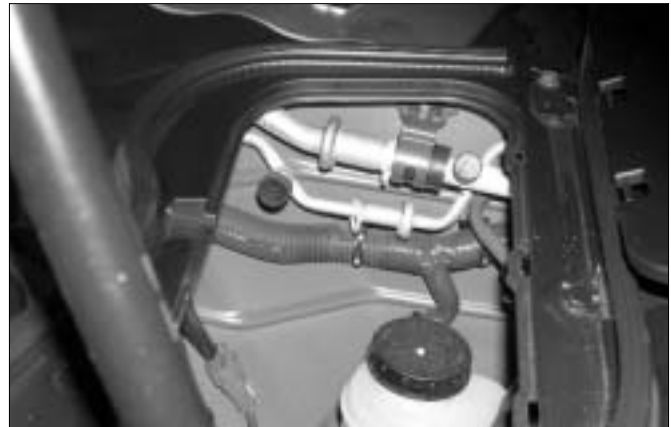
Figure 9. The cover is off and there's the brake fluid reservoir, all right. But both A/C service valves are there too.

On the new Infiniti FX35 and FX45 SUVs, the underhood has the typical plastic look. Ignore the labeling on the BRAKE FLUID cover, lift it up and although the brake fluid reservoir is there, so are both A/C service valve fittings, nicely accessible (Figures 8, 9).

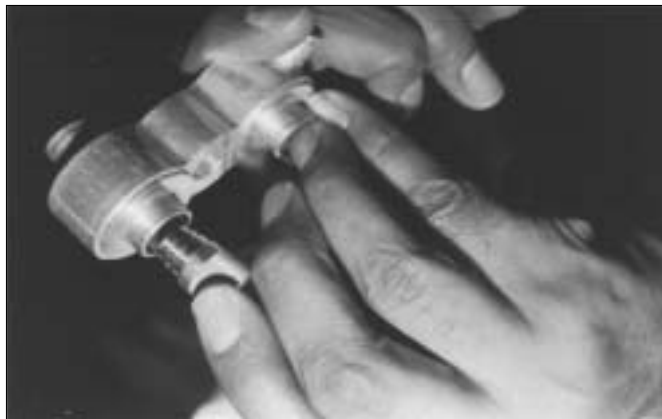
Figure 12. The AirSept kits use sizing gauges that enable the technician to pick the right screen for the compressor manifold's suction port. The early kits with three screens were for GM systems with Delphi compressors and the sizing gauge (shown) has just three steps. If this is used for other than Delphi compressors, you could select a wrong-size screen. The new kits, with eight screens, span a greater range and cover most systems, and contain a double-end design sizing gauge with a total of eight steps. However, most is not all, and even if the screen is supposed to fit an application, an occasional out-of-tolerance manifold port might not hold a screen. But the gauge tells you.
